- Introducing Rescue Robots “Quince”
- Operations of Quince at Fukushima NPS
- Lessons learned from the operations

Objective of Quince Project (2005-2011)

Quince Robots for Fukushima

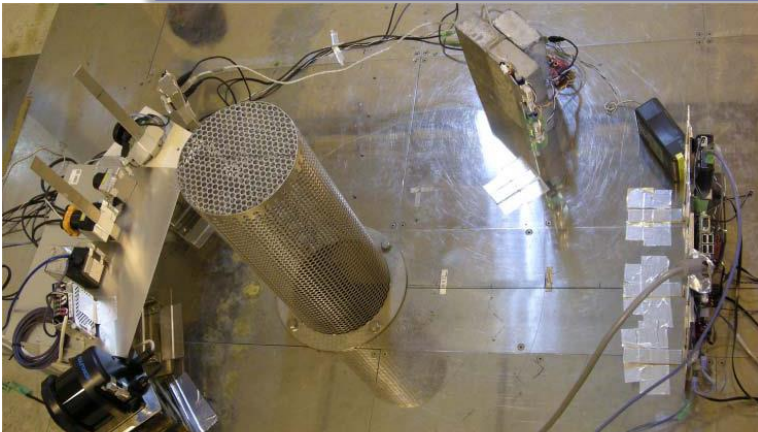
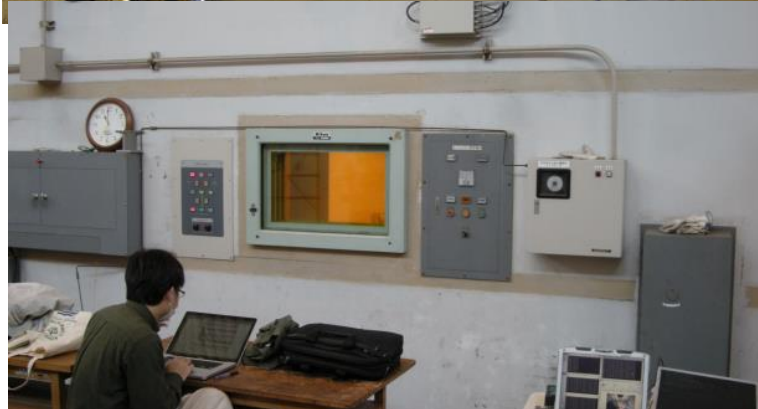
Gamma ray irradiation test

Takasaki Advanced Radiation Research Institute,
Japan Atomic Energy Agency (JAEA)

Estimated to be survived over 400h in
40mSv/h environment

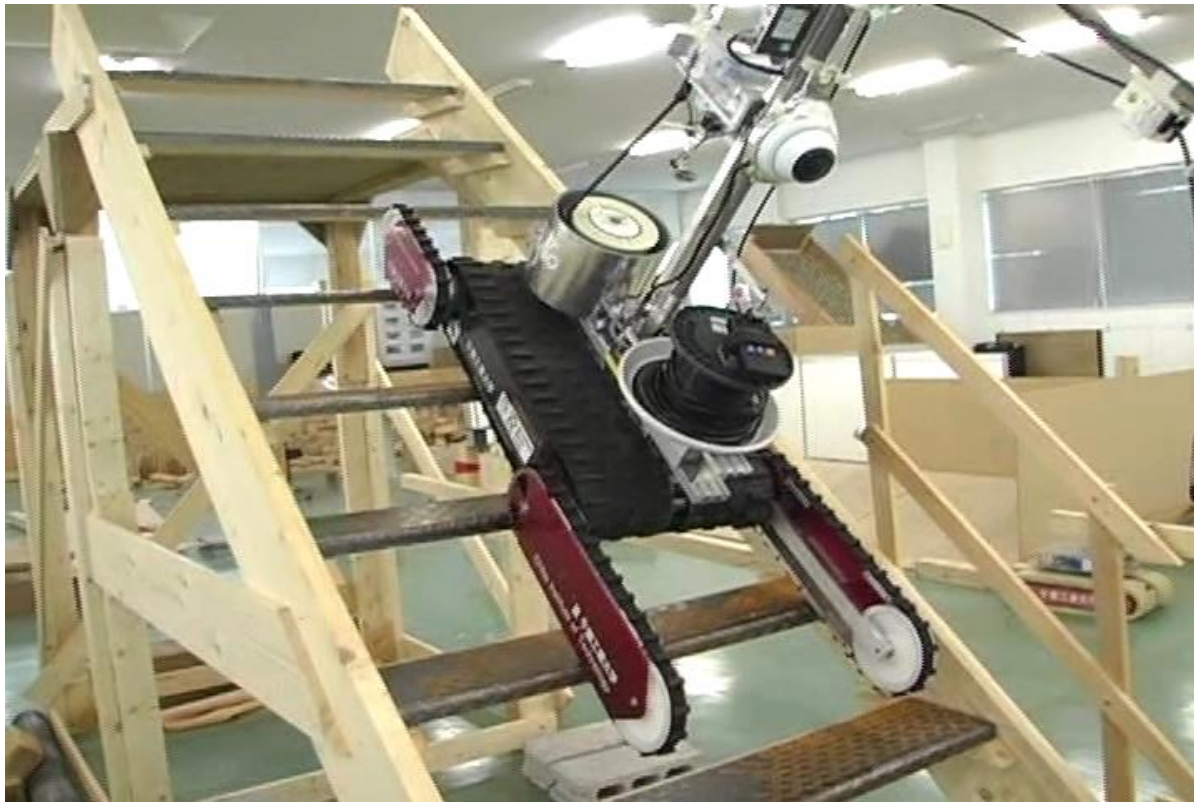
Mobility

Steep, Slippery

Verified with mock up Environment

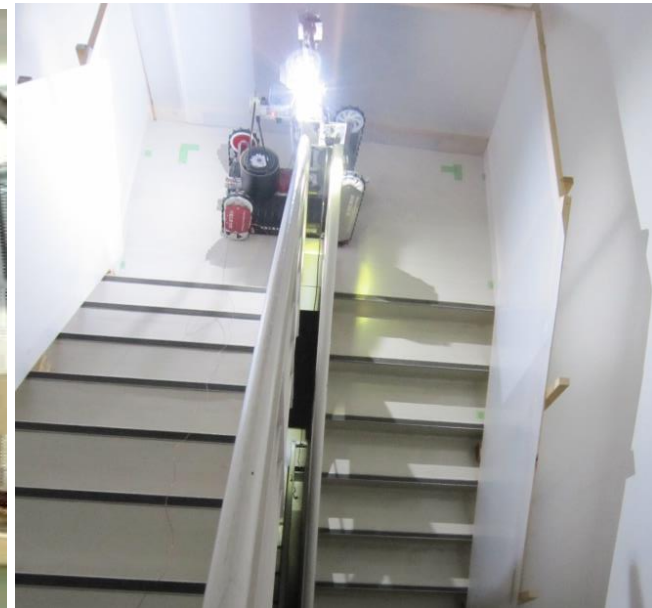
Narrow

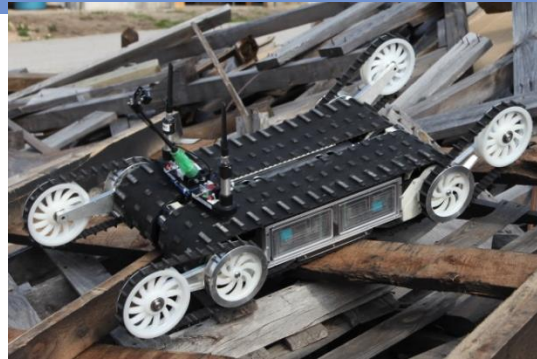
Quince 1

Released on June 20 2011

Quince (May 2011)

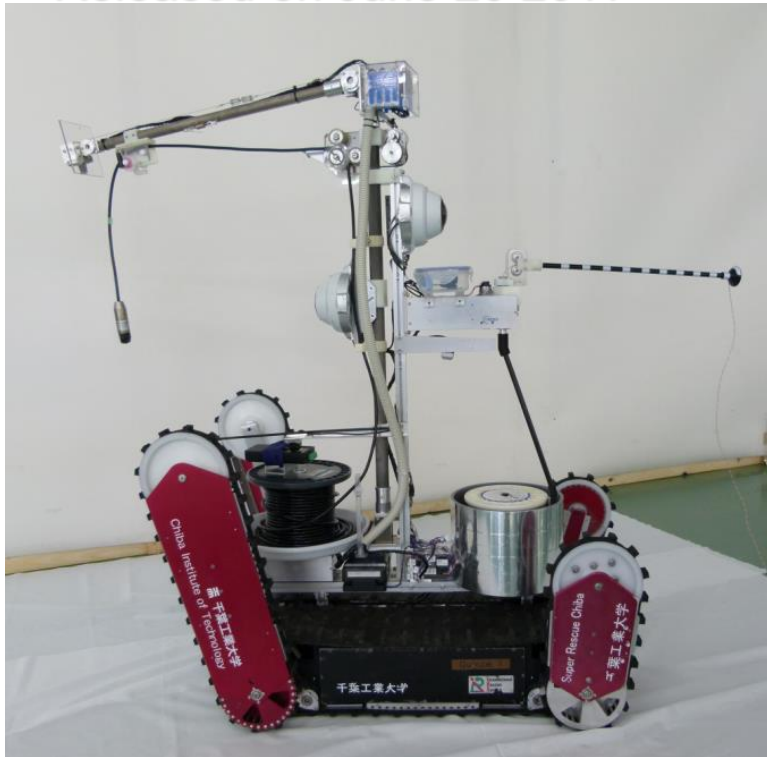
Quince 2, 3

Released on February 20 2012

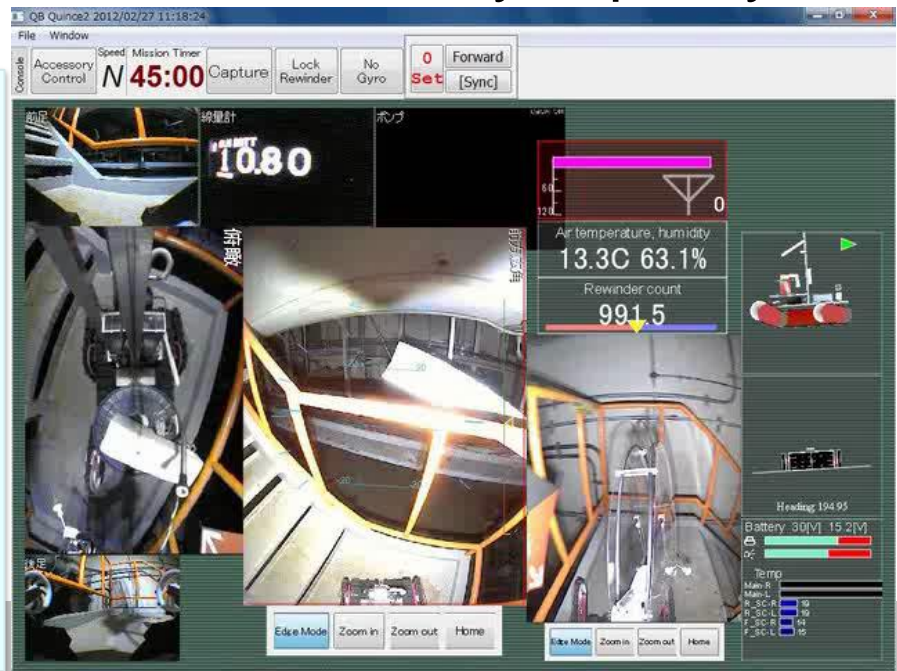
2012/2/27 Unit 2, 5F

Approach 58min, Exit 46min

Surveillance 76min

10:33 Entry

11:20 Arrived to 4F

11:31 Arrived to 5F

12:47 Left 5F

13:33 End

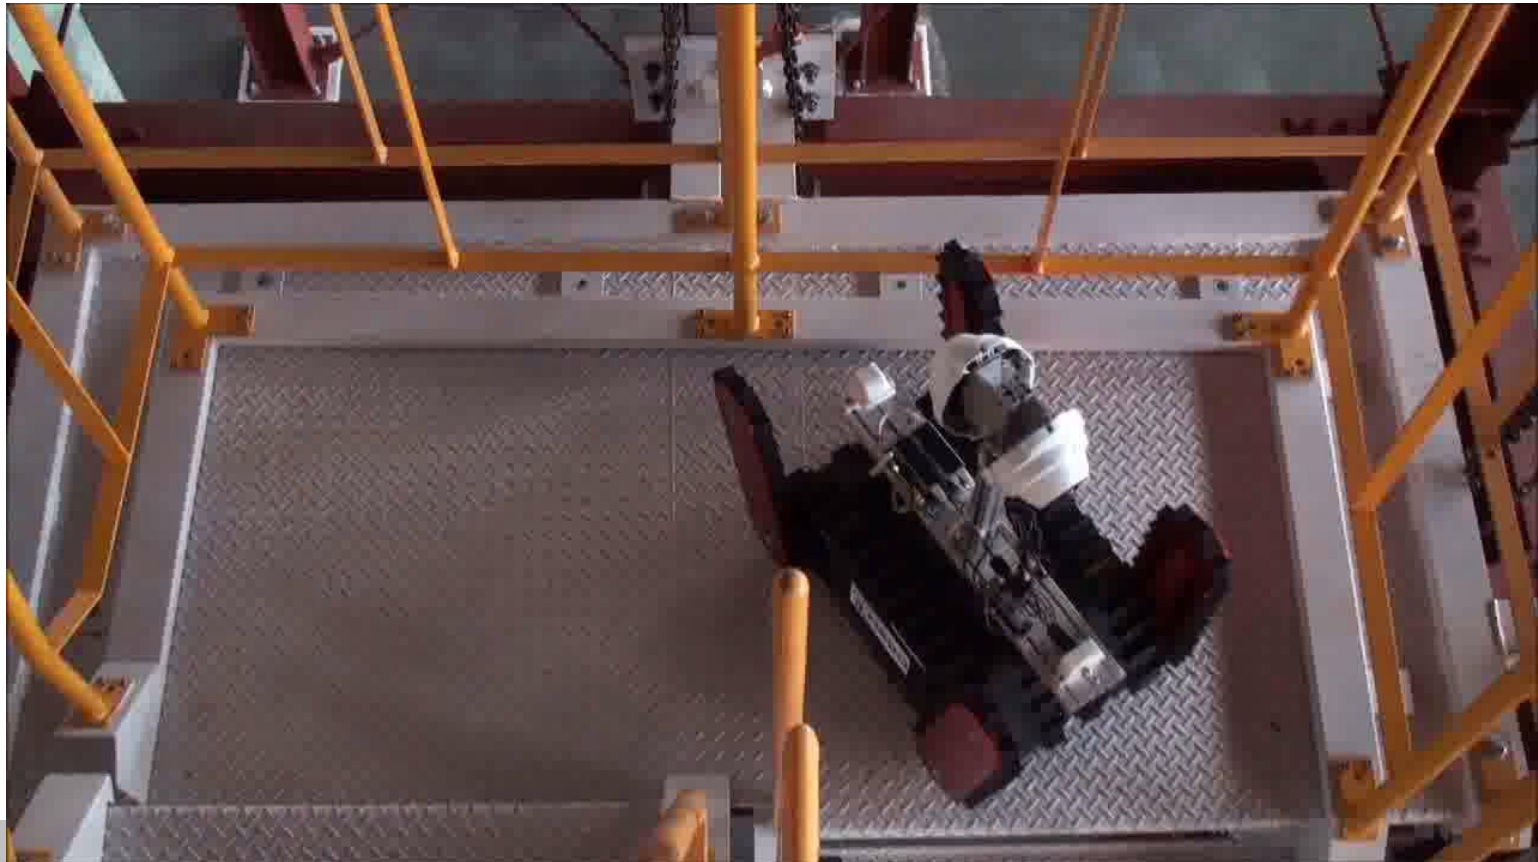
- Smaller Robot “Sakura”
 - Width 420 Length 530
 - (Quince: 490 x 700)
